# The Road Inventory of Alchesay National Fish Hatchery Whiteriver, AZ

Prepared By:  
Federal Highway Administration  
Central Federal Lands Highway Division  
April 2008

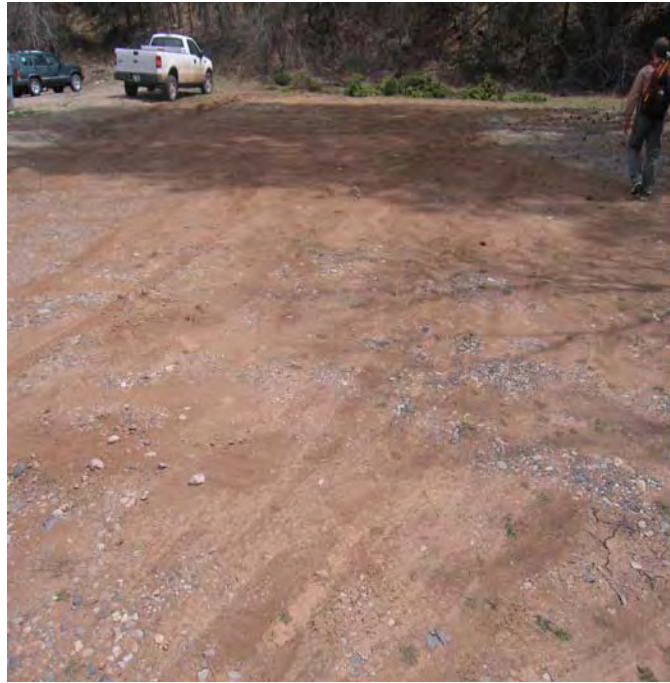
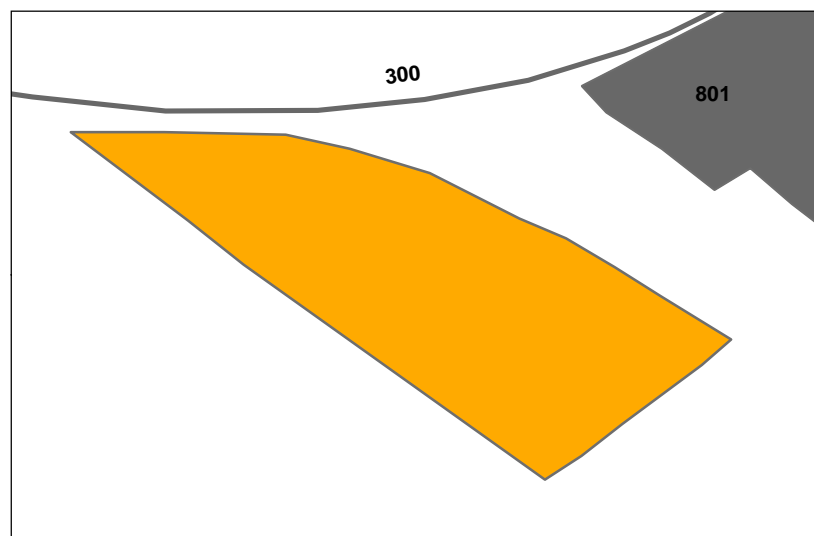
## Route 800: Employee Parking 1

| Asset Number | Date Visited | Surface Type | Area (sq ft) | Condition | Cost to Improve |
|---|---|---|---|---|---|
| | 4/9/2008 | Native | 2876 | Poor | \$2300 |

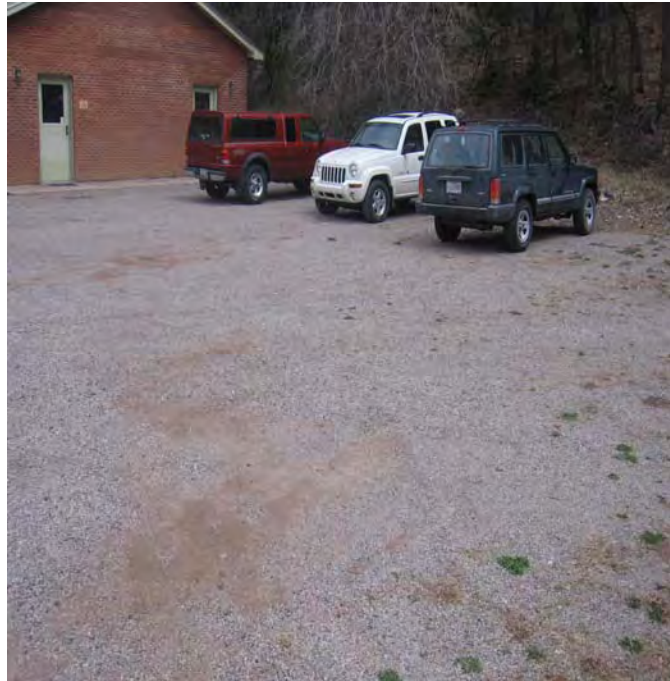
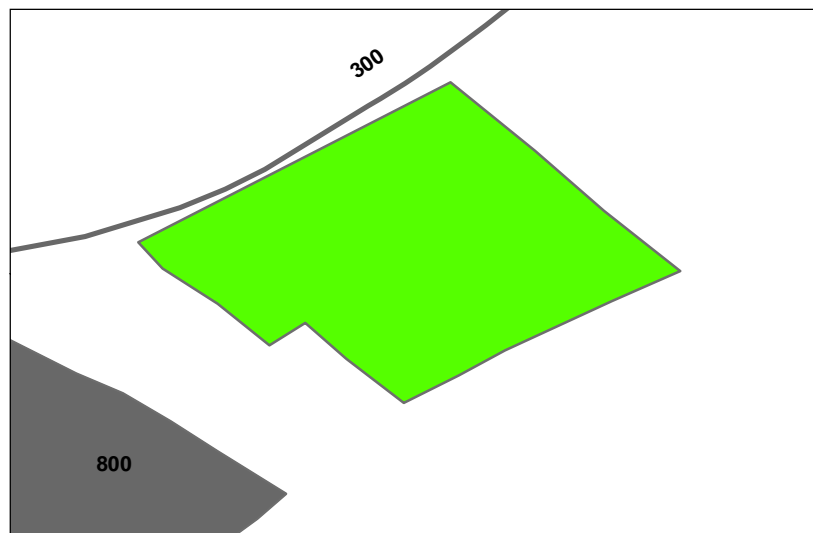
## Route 801: Employee Parking 2

| Asset Number | Date Visited | Surface Type | Area (sq ft) | Condition | Cost to Improve |
|---|---|---|---|---|---|
| | 4/9/2008 | Gravel | 2661 | Good | \$400 |

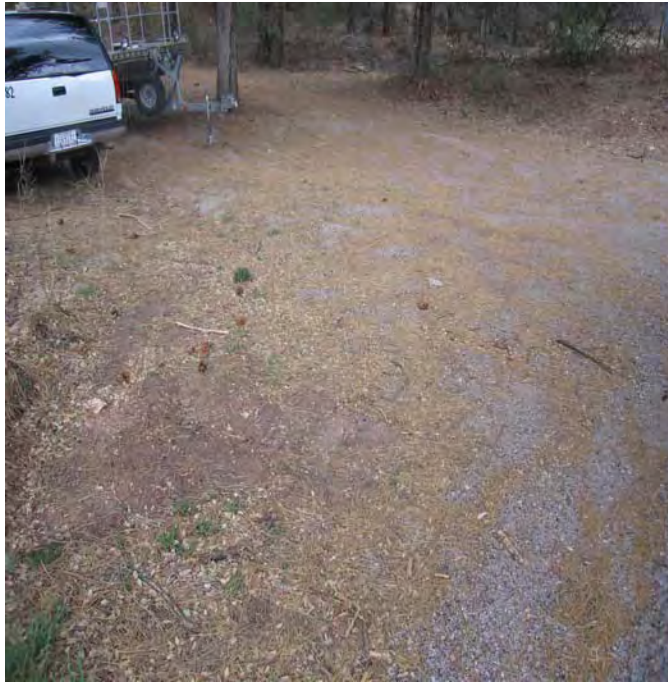
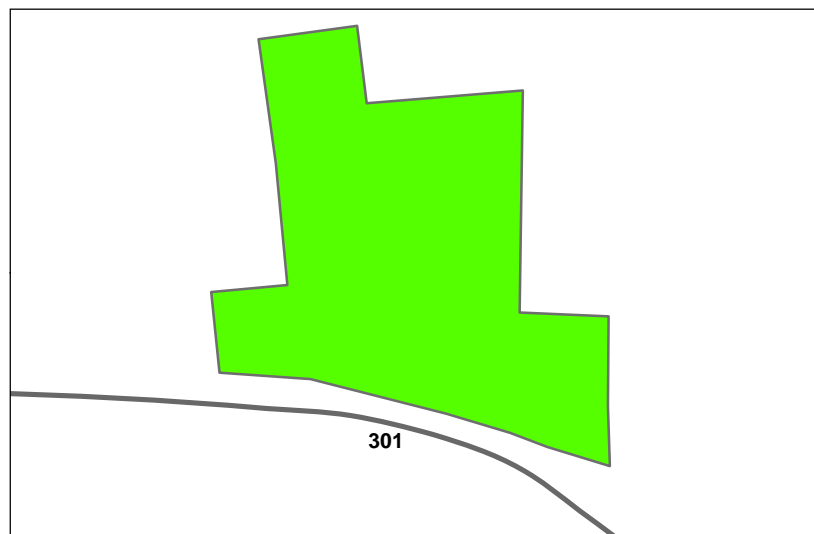
## Route 802: Fisheries Office Parking

| Asset Number | Date Visited | Surface Type | Area (sq ft) | Condition | Cost to Improve |
|---|---|---|---|---|---|
| | 4/9/2008 | Gravel | 1609 | Good | \$200 |

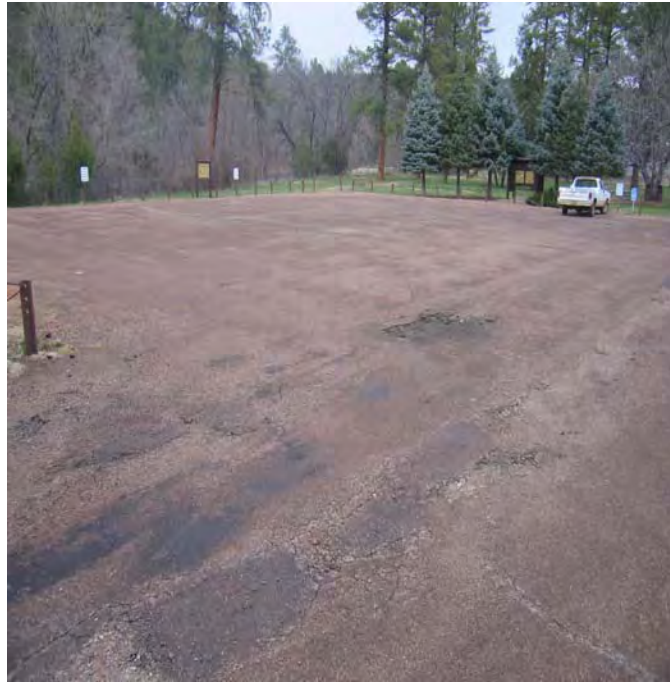
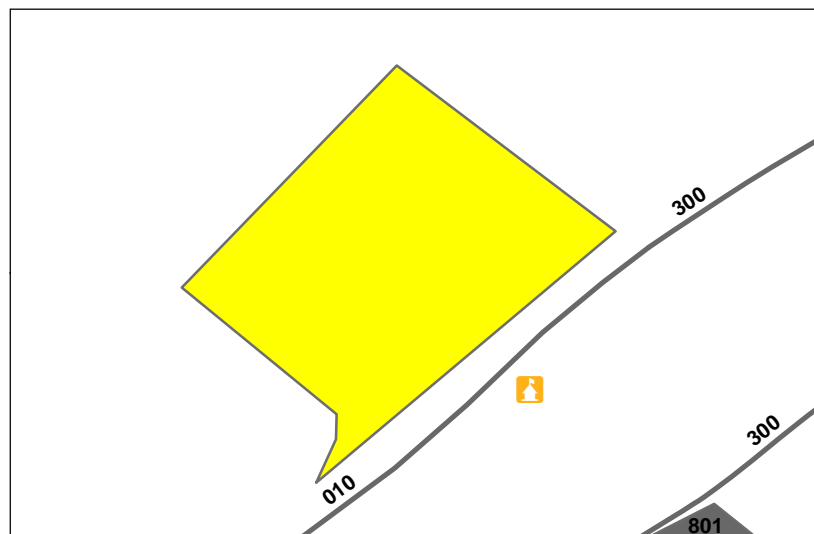
## Route 900: Visitor Parking

| Asset Number | Date Visited | Surface Type | Area (sq ft) | Condition | Cost to Improve |
|---|---|---|---|---|---|
| 10008766 | 4/9/2008 | Asphalt | 12000 | Fair | \$10000 |
